Some Enlightening Case Histories on Lightning Damage

Thomas Key, Doni Nastasi and Kermit Phipps
EPRI PEAC Corporation
Knoxville TN

François D. Martzloff
National Institute of Standards and Technology
Gaithersburg MD

Reprinted from *Proceedings, 25th International Conference on Lightning Protection - Rhodes, September 2000*

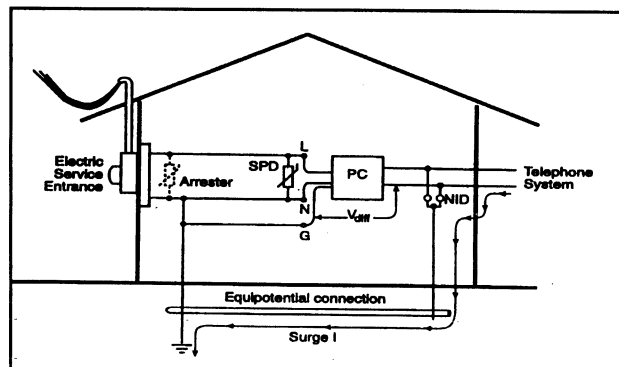
Figure 1 — Scenario for shifting reference potentials between power and telephone systems

In the scenario of Figure 1, a personal computer (PC) is connected to both the power system and the telephone system. The surge current "Surge I" flows from the telephone system toward the common grounding point via the protective device "NID" at the point of entry, and the equipotential conductor. This current produces a magnetic field which couples into the loop formed by the power branch circuit, the telephone premises wiring lines to the PC, and the equipotential conductors. The voltage thus induced in the loop appears across the telephone and power ports, with upsetting or damaging consequences.

In a laboratory replica of this configuration [2], a peak voltage of 4,3 kV was recorded across the two ports for a typical surge injected at the telephone entrance. A similar situation exists for a surge impinging on the video port of a TV receiver. The tests reported in 2.3 below show that this level can cause damage.

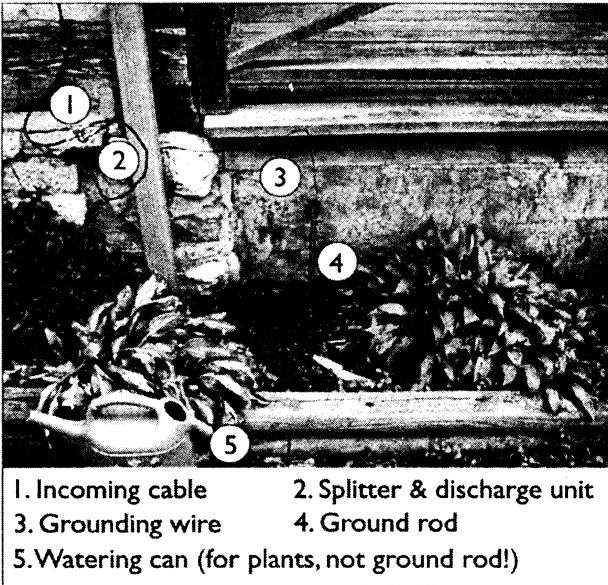
Figure 2 — Cable TV entrance

In the Cozy Cabin installation, the power service entrance was located at one end of the house, while the cable TV service entrance was located at the opposite end. Furthermore, a visit to the site revealed that the cable TV shield was grounded only by a questionable ground rod next to the house foundation (within the drip line, and thus in dry soil, see Figure 2). This cable TV grounding electrode was not bonded to the grounding electrode of the power service entrance, a clear violation of the U.S. National Electrical Code ("NEC", NFPA 70, 1999) [4].

Following the visit to the site by the authors, the local cable TV company was informed of this situation and took what they believed an appropriate action: the incoming cable was first routed under the house, in the crawl space, to allow bonding the shield to the power service grounding connection. From there, the cable was returned to its original point of entry into the house, at the opposite end. This modification did correct the NEC violation but left the arrangement in the topology shown in Figure 1.

However, the interaction was not pursued further with the cable company. A recommendation was made to the owner, to install a surge reference equalizer [5] for each piece of video equipment. After that was done, no damage occurred during the next lightning season. Of course, it is still too early to declare victory over Zeus and Murphy, but encouraging when compared to a previous history of two incidents within a few months.

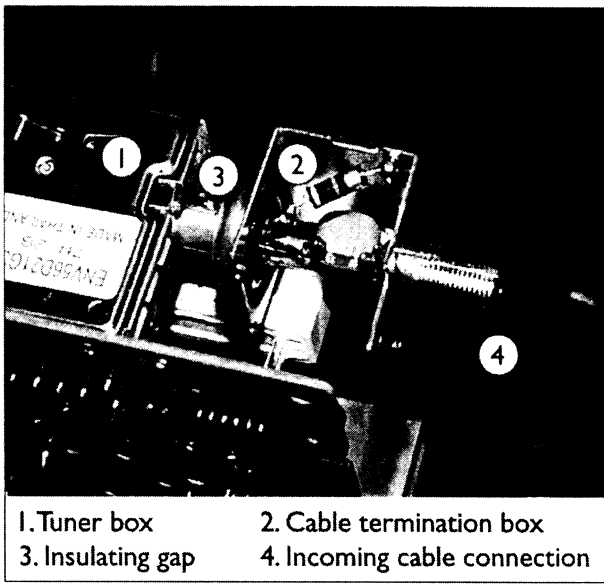
Figure 3 — Insulating gap at signal input

One of the failed TV receivers from the Cozy Cabin was made available to the authors for examination. No evidence of damage was found on the power side of the chassis and the related components, but a clear indication of surface flashover was observed along the insulation of the gap intended to isolate the cable input 'ground' termination (connected to the incoming cable shield) from the shielding can of the tuner (connected to one of the power cord conductors, see Figure 3).

After cleaning the carbonized path of the flashover, a 0,5 μ s – 100 kHz Ring Wave was applied in incremental steps between the two conductors of the power cord, bonded together, and the shield connector of the cable input: flashover occurred at 2 kV. By removing the material to a greater depth and covering it with epoxy, the gap did withstand a greater level, and failed at 2,5 kV. That flashover occurred at another part of the original insulation, thus providing valid information on the original withstand capability.

This case study illustrates the classic situation of separate service entrances, compounded with incorrect bonding. The examination and test demonstrate that at least 2,5 kV were developed across the power port and the cable TV port of the receiver under a condition of distant or nearby lightning strike

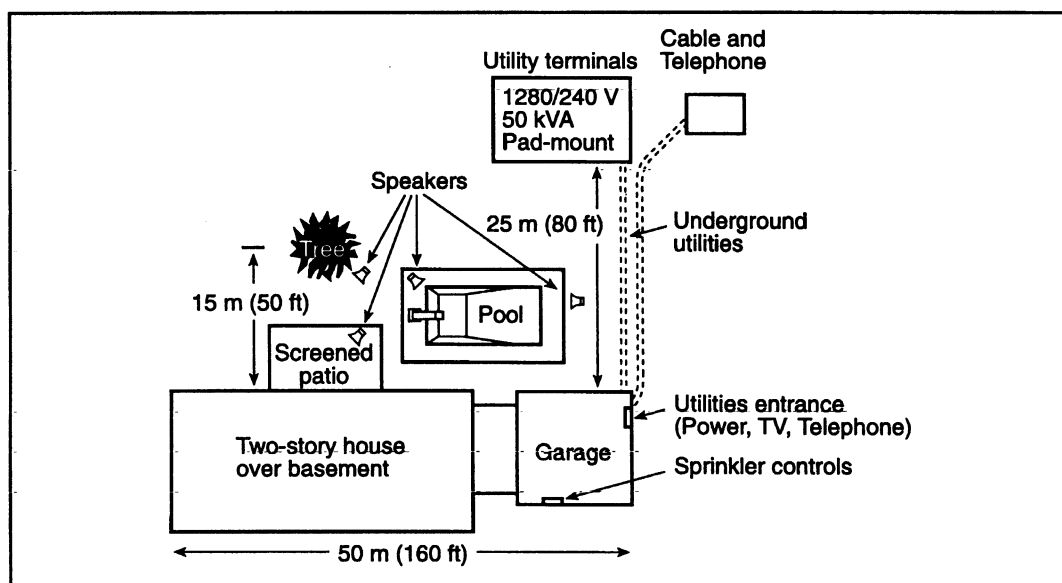
Figure 4
Schematic configuration of the Rambling Residence

The overall physical layout of the house, damaged tree, and electronic equipment are shown in Figure 4. The tree that was struck is much taller than the house and is the tallest of the trees in the immediate area. The bark was stripped from the tree trunk for most of its height. The tree trunk is only approximately 15 m from the house and even closer to the patio, where some of the audio speakers were installed. Outdoor speakers are also located in the pool area and connecting walkways.

In the audio amplifiers, as noted above, the power supplies of the units were not damaged, but their output transistors that drive the speakers and the speakers themselves were damaged. Thus, it was speculated that the surge energy had been coupled into the speaker wires, which are probably very long and very near to the lightning strike, rather than as a "power-line surge."

The visit to the installation verified this theory. The home entertainment equipment, including amplifiers, is centrally installed in the basement of the house. Speakers are located throughout the house, the patio, and the swimming pool area. The wire length between the outdoor speakers and the central amplifier is about 30 m, and some of the wires run within 10 m of the tree trunk.

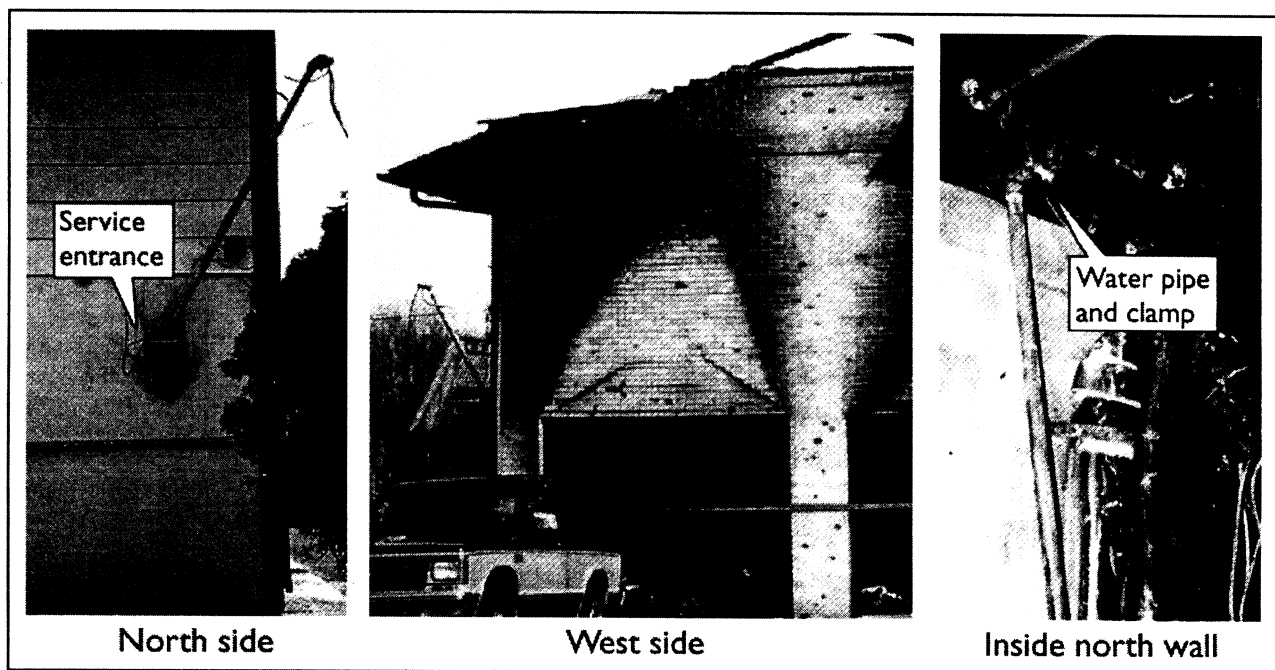
Figure 5 — The Standard Suburban aftermath

In this case, which occurred in a suburban, semi-rural hilly area, the post-strike investigation revealed that the overhead service drop to the house (involving a span of about 20 m across the street) had been severed by melting at the point of strike. From there, the current traveled to the revenue meter (typically on the outside wall in U.S. practice), where a ground conductor is normally installed with a short run to the earthing electrode of the house. Instead, according to the practice when constructed in the 1970s, a cold water pipe was allowed to be the main earthing electrode. In this case, the conductor for the earthing electrode entered the garage and was routed upward near the ceiling with several bends before it was bonded to a copper water pipe. Without any better path to earth, the lightning current had apparently followed the same route, severing the bare conductor while seeking the well-grounded water pipe (see Figure 5).

As shown in the photographs of Figure 5, the service entrances were overhead and without any direct path to earth. This type of installation would not be approved by current US practice, which requires a direct connection to a driven ground rod in addition to any other supplemental electrodes such as the cold water pipe. One of the main reasons that the practice was modified is the growing use of PVC or plastic water pipe.
